Structural breakdown in high power GaN-on-GaN *p-n* diode devices stressed to failure

Cite as: J. Vac. Sci. Technol. A 38, 063402 (2020); doi: 10.1116/6.0000488

Prudhvi Peri,^{1,a)} Kai Fu,² Houqiang Fu,² Yuji Zhao,² and David J. Smith³

The morphology of GaN-on-GaN vertical *p-n* diode devices after reverse-bias electrical stressing to breakdown has been investigated. All failed devices had irreversible structural damage, showing large surface craters that were $\sim 15\text{--}35\ \mu\text{m}$ deep with lengthy surface cracks. Cross-sectional electron micrographs of failed devices showed substantial concentrations of threading dislocations around the cracks and near the crater surfaces. Progressive ion-milling across damaged devices revealed high densities of threading dislocations and the presence of voids beneath the surface cracks; these features were not observed in any unstressed devices. These results should serve as a useful reference for future reliability studies of vertical high-power GaN devices.

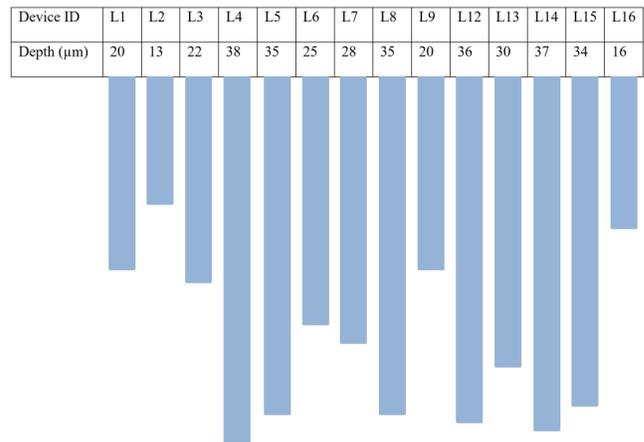
FIG. 2. Schematic illustrating maximum crater depths of Series L devices that had been stressed to failure.

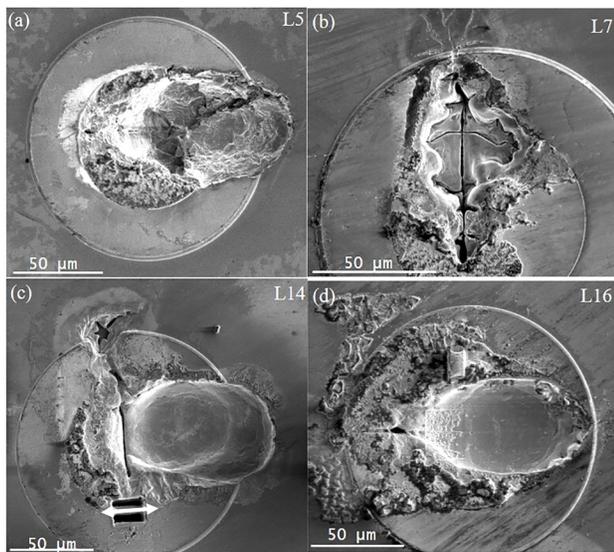
FIG. 1. SEM images showing examples of devices that had been reverse-bias stressed to electrical breakdown, revealing extensive surface damage, including deep craters and wide cracks: (a) Device L5, (b) Device L7, (c) Device L14, and (d) Device L16.

Examples of plan-view SEM images of devices L5, L7, L14, and L16 after they were reverse-bias stressed to breakdown are shown in Fig. 1. This set of devices had been regrown with an insertion layer of 250 nm, followed by another 500 nm *p*-GaN, after the surface layer of the original UID-GaN had been chemically treated. All stressed devices showed extensive, craterlike surface pits, and most also showed evidence for lengthy cracks extending across parts of the craters and even outside the device region in some cases. Sixteen devices were stressed to breakdown and all 16 showed similar craterlike surface damage with varying crater depths. The measured depths of these craters ranged from 13 to 38 μm , as shown schematically in Fig. 2.

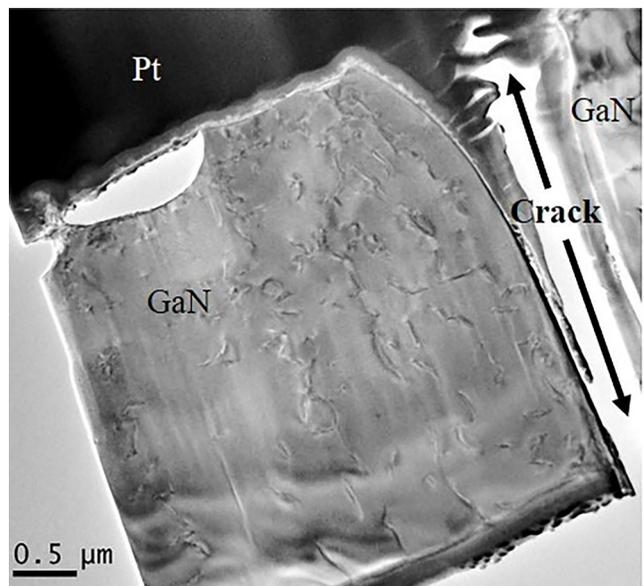
FIG. 3. TEM cross section image of Device L14 from the lift-out location marked in Fig. 1(c), showing the left side of cracks with many dislocations more concentrated toward the crater surface and crack.

Lift-out with the FIB was performed across the crack on Device L14, as indicated by the arrow in Fig. 1(c), and the corresponding TEM image is shown in Fig. 3. This cross-sectional image reveals a high density of dislocations along the left side of the crack, which appear to be more concentrated toward the GaN surface and adjacent to the crack. For comparison, Fig. 4(a) shows a cross-sectional TEM image of an unstressed device, where the white arrow indicates the position of the interface between *p*-GaN and the insertion layer. No dislocations or cracks are visible and no structural damage between the insertion layer and the UID-GaN layer due to surface treatment can be observed. The enlargement in Fig. 4(b) shows the *p*-GaN/insertion layer/UID-GaN area where there are no visible defects or surface damage, although the top *p*-GaN layer shows evidence for Mg precipitates.

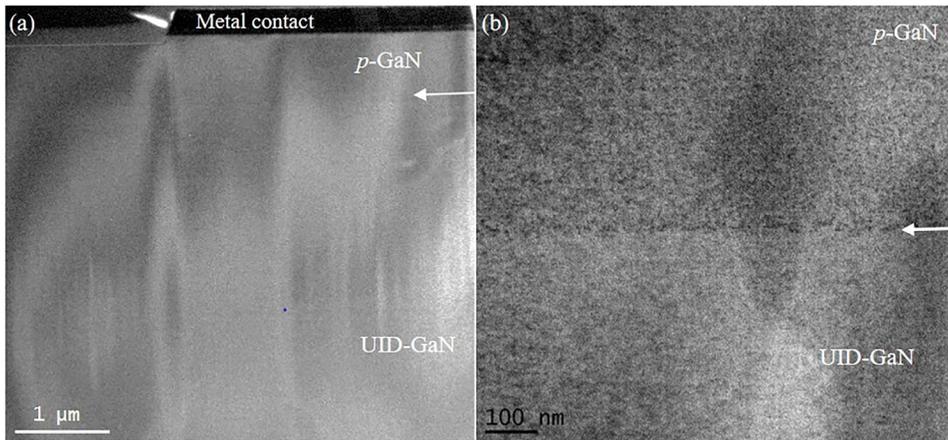
FIG. 4. (a) TEM cross-sectional image of unstressed devices showing the absence of dislocations over the entire lift-out sample and (b) enlargement of the *p*-GaN/insertion layer/UID-GaN region showing no surface-treatment damage or defects.

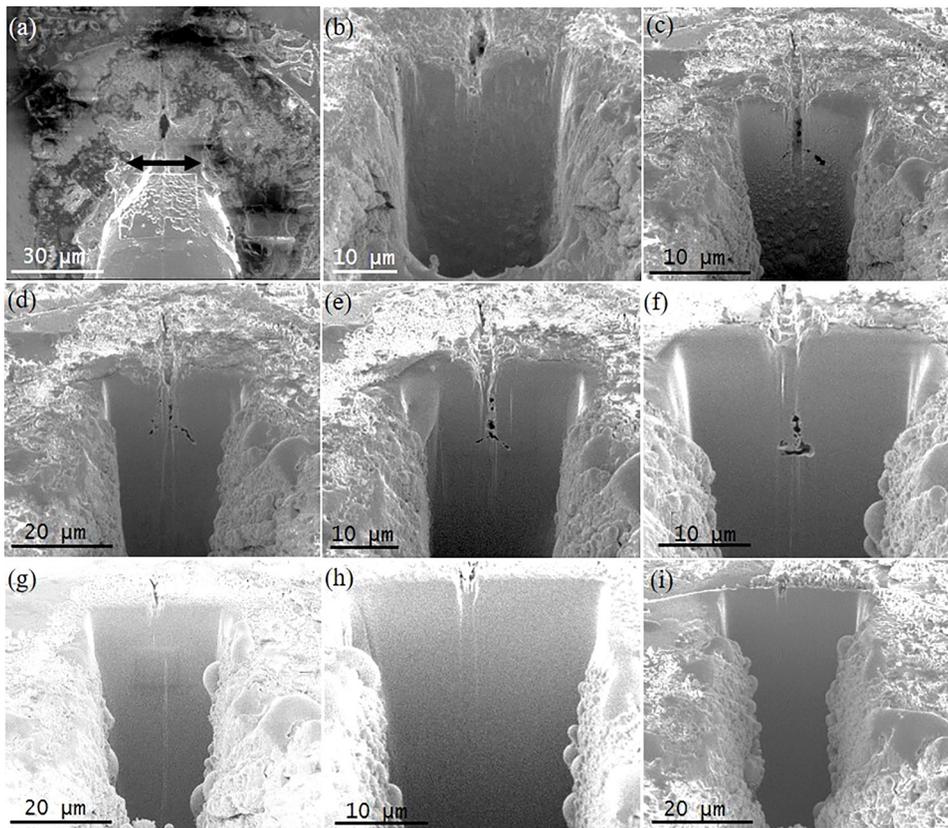
FIG. 5. Series of SEM images of Device L16, showing progressive cross-sectional milling across area of 30 μm (length) × 25 μm (depth): (a) plan-view image showing the location where milling started (black double-headed arrow); (b) cross-sectional image after 5 μm of milling, showing the presence of voids right below the surface crack; (c) cluster of voids; (d) voids extending from the surface just below crack to ~16 μm deep; (e) voids and TDs; (f) presence of TD clusters all over area; (g) and (h) TDs extending from the substrate; and (i) milled almost to the edge of device.

In order to appreciate the full extent of defect formation in the failed devices, Device L16 was progressively milled in cross section across the surface crater and then repeatedly imaged *in situ* with the SEM after another roughly 5 μm had been milled away. Figure 5(a) shows a plan-view SEM image of the original device after failure before commencement of trenching. Milling started at the top of crater at the position indicated by the arrow and then proceeded progressively upward. Figures 5(b)–5(h) are a series of SEM images showing the progression of this milling over an area of roughly 30 \times 25 μm^2 . Figure 5(b) reveals a collection/cluster of voids that are present in the GaN substrate beneath the crack. Figures 5(c)–5(e) show parts of the same void cluster after the additional material, about 5 μm at a time, had been removed. Figures 5(c)–5(f) show a

cluster of threading dislocations at the center of image, right below the crack, and away from the surface crack. Figure 5(e) shows a threading dislocation extending from the crater surface to deep within the substrate over a vertical distance of almost $80\ \mu\text{m}$.

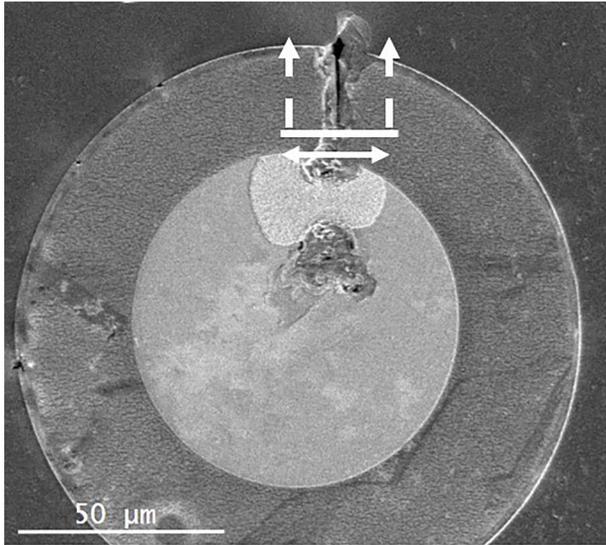
FIG. 6. Plan-view SEM image of Device A1 after reverse-bias breakdown at ~ 1.27 kV, showing surface pits and crack. White arrowed lines indicate the location of cross-sectional milling and double-arrowed line indicates the location of TEM lift-out.

In addition to the chemical etching used for the L-series, Devices A1 and A2 of the A-series were ICP dry etched, followed by growth with $50\ \text{nm}$ of the GaN insertion layer and overgrowth with $500\ \text{nm}$ of *p*-GaN. Device A1 suffered electrical breakdown at a reverse bias of $\sim 1.27\ \text{kV}$. It was then observed for surface anomalies, as shown by the SEM image in Fig. 6. The surface shows pits near the center of the circular contact with a long crack that extends across part of the device to outside the device area. The crater and the crack surface morphology appear similar to that observed for the L-series devices despite the considerable difference in breakdown voltages.

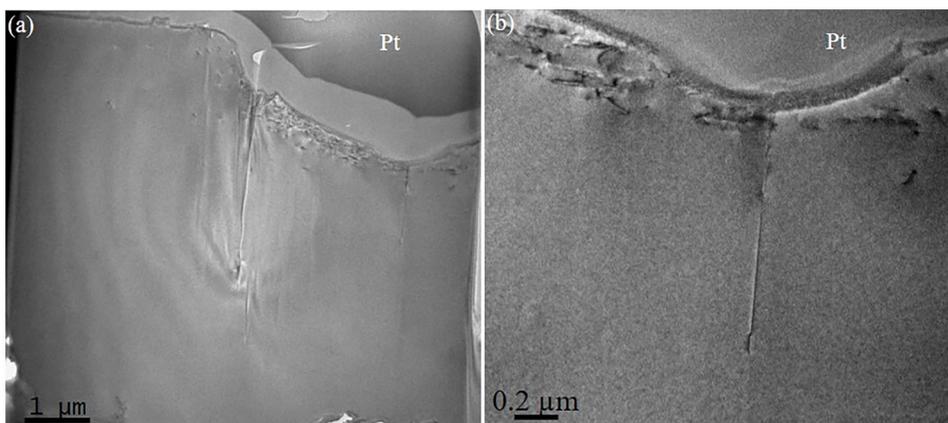
FIG. 7. Cross-sectional TEM images of Device A1 lift-out across the surface crack from location marked with double-arrowed line in Fig. 6: (a) low-magnification image showing large 4- μm -deep crack, smaller cracks, and the presence of dislocations concentrated near the cracks and surface and (b) high-magnification image showing small 2- μm -deep crack and surrounding defects.

A cross-sectional sample suitable for TEM observation was lifted-out across the visible crack of Device A1, as marked in Fig. 6 by the double-headed arrow. Figure 7 shows corresponding TEM images. Figure 7(a) reveals that the entire top surface region here is riddled with dislocations, not unlike the L-series devices, and a crack is also visible that penetrates more than $4\ \mu\text{m}$ from the crater surface. Figure 7(b) from an adjacent area shows another crack that extends almost $2\ \mu\text{m}$ downward from the crater surface. Dislocations here are concentrated close to the crack and along the top surface, as clearly visible in Fig. 7(b). The GaN top surface is not flat/even because of the irregular loss of surface material that occurred during the device breakdown.

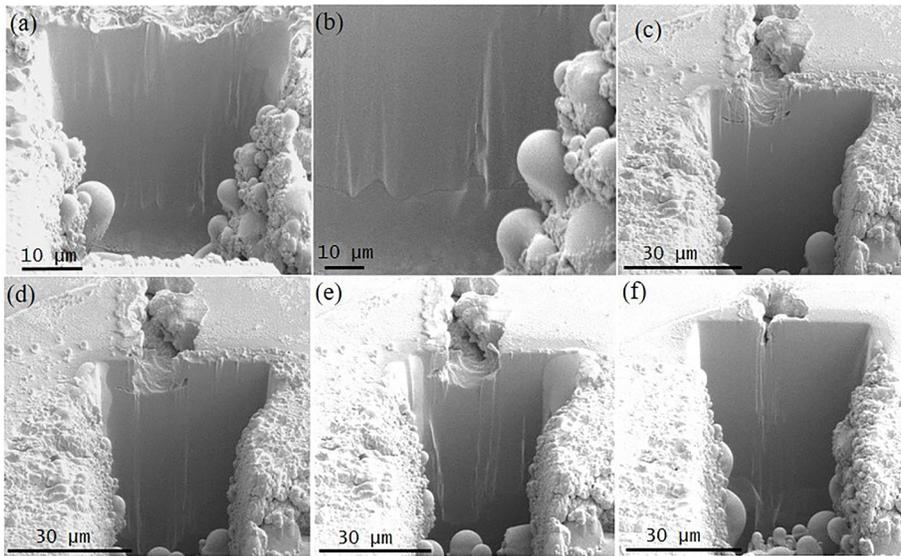
FIG. 8. Sequential series of SEM images of Device A1 after progressive cross-sectional milling across area of $40\ \mu\text{m}$ (length) \times $25\ \mu\text{m}$ (depth) from the location marked with arrowed white lines in Fig. 6: (a) TDs all over milled area; (b) high-magnification image focused on TD that extended $\sim 49\ \mu\text{m}$ down from the crater surface; (c) voids concentrated nearer to cracks; (d) surface crack that appears to be $\sim 15\ \mu\text{m}$ deep extending into the device; (e) TDs near and away from cracks and extending deep from the substrate; and (f) milling stopped at the edge of device and surface crack extending outside devices is still observed.

Figure 8 shows a sequence of cross-sectional SEM images of Device A1 after progressive milling had been done along the direction indicated by the arrowed lines in Fig. 6. Figures 8(a) and 8(c) reveal the presence of TDs all across the milled area, while Fig. 8(b) shows a TD that extends almost $49\ \mu\text{m}$ downward from the crater surface. Figures 8(d) and 8(e) show that the surface crack is almost $15\ \mu\text{m}$ deep, and that TDs are present everywhere. For comparison, Fig. 9 shows TEM images of the equivalent Device A2, which was not subjected to any electrical tests. Figure 9(a) shows that no dislocations or

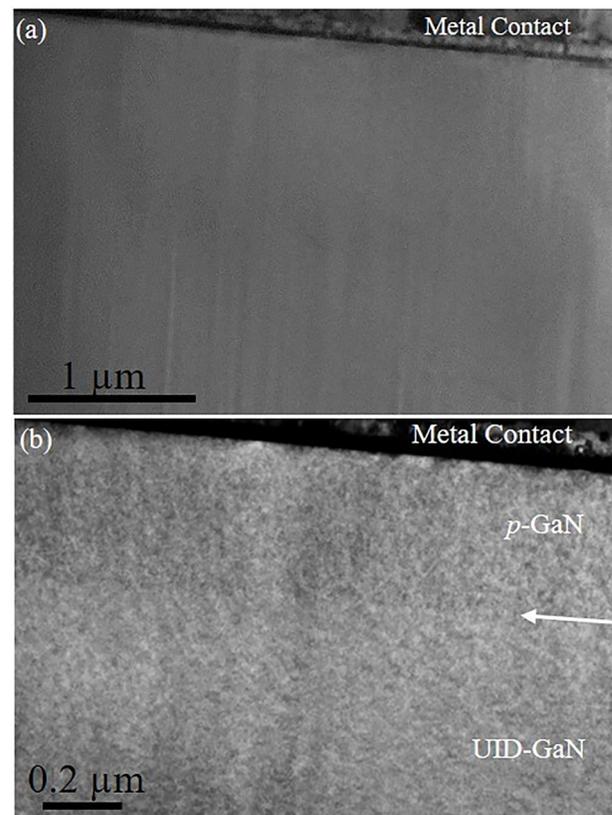
FIG. 9. Cross-sectional TEM images of Device A2 which was not subjected to any electrical tests: (a) low-magnification image shows no cracks or dislocations and (b) high-magnification image of the *p*-GaN/insertion layer/UID-GaN area shows no visible etch damage or defects.

cracks are present in the lifted-out area. The enlargement in Fig. 9(b) shows the *p*-GaN/insertion layer/UID-GaN area, and no etching-based damage or structural defects are visible.
